# Manhole Inspection Summary

Manhole # S15AA1031MH

**Location** Address: **REAR- 3722 REISTERSTOWN RD**

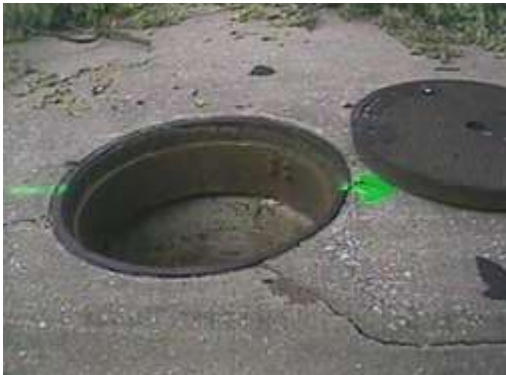
Location View

DEBRIS ON BENCH.

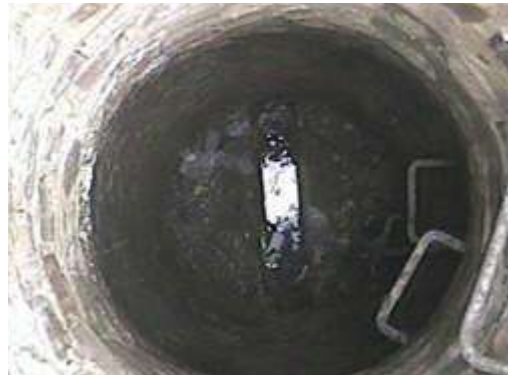
Top View

DEBRIS ON BENCH.

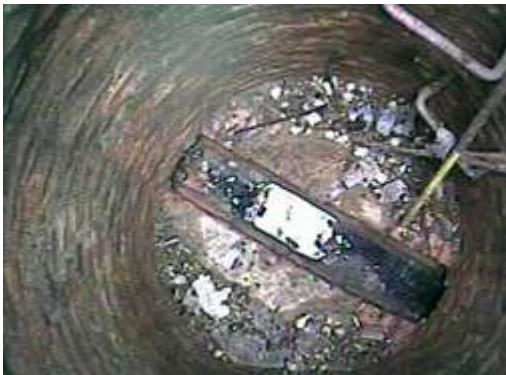
Defect 1

**Surcharge** ☒ **Evidence Of Surcharge** Depth: **3** (ft.) ☐ Active Surcharge Present

EVIDENCE OF SURCHARGE ON STEP  
AND DEBRIS IN CHANNEL AND ON  
BENCH

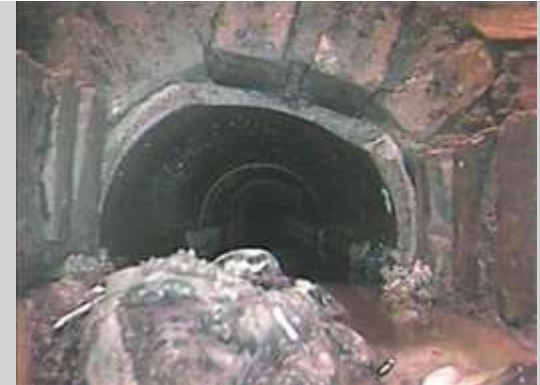
12 O'Clock Outflow

8 in. Circular Gravity Sewer  
Pipe Out @ 12 O'Clock

Pipe Height: (in.) Direct  
Pipe Material: **Clay** ☐ Pipe Lined  
Invert Depth: **10.17** (ft.) Flow Characteristics: **Slow**  
Deposits: ☐ None ☐ Mud ☐ Sludge ☒ **Debris** ☐ **Grease**  
Silt Depth: **1.5** (in.) Deposits Extent: **Medium**  
Infiltration: **None** Pipe Seal Cond: **Cracked**

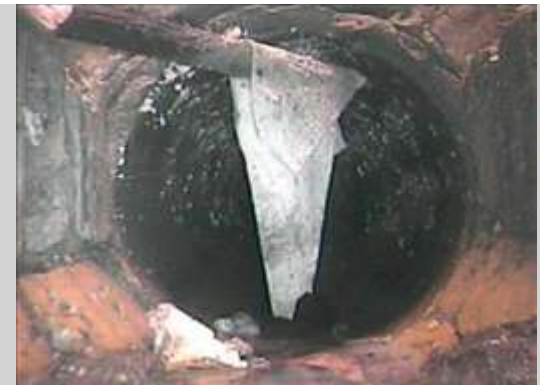
6 O'Clock Inflow

8 in. Circular Gravity Sewer  
Pipe In @ 6 O'Clock

DEBRIS IN CHANNEL.

Pipe Height: (in.) Direct  
Pipe Material: **Clay** ☐ Pipe Lined  
Invert Depth: **10.14** (ft.) Flow Characteristics: **Slow**  
Deposits: ☐ None ☐ Mud ☐ Sludge ☐ Debris ☒ **Grease**  
Silt Depth: **0.5** (in.) Deposits Extent: **Light**  
Infiltration: **None** Pipe Seal Cond: **Broken**
